WE-THALKO-CHEE (LITTLE BIG WATER)

Mark Fulkerson, Ph.D., P.E.
November 15, 2017

WITHLACOOCHEE RIVER WATERSHED INITIATIVE

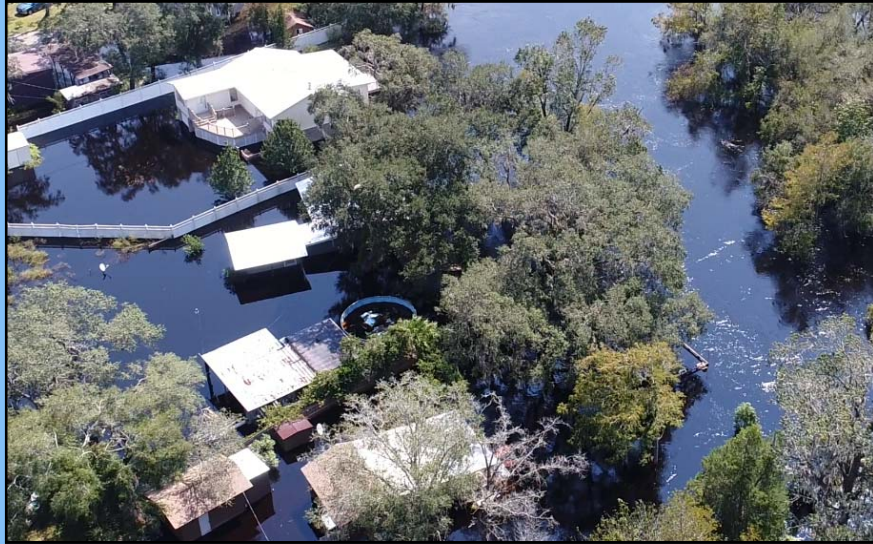
(SR 50, 2017)

FLOODING

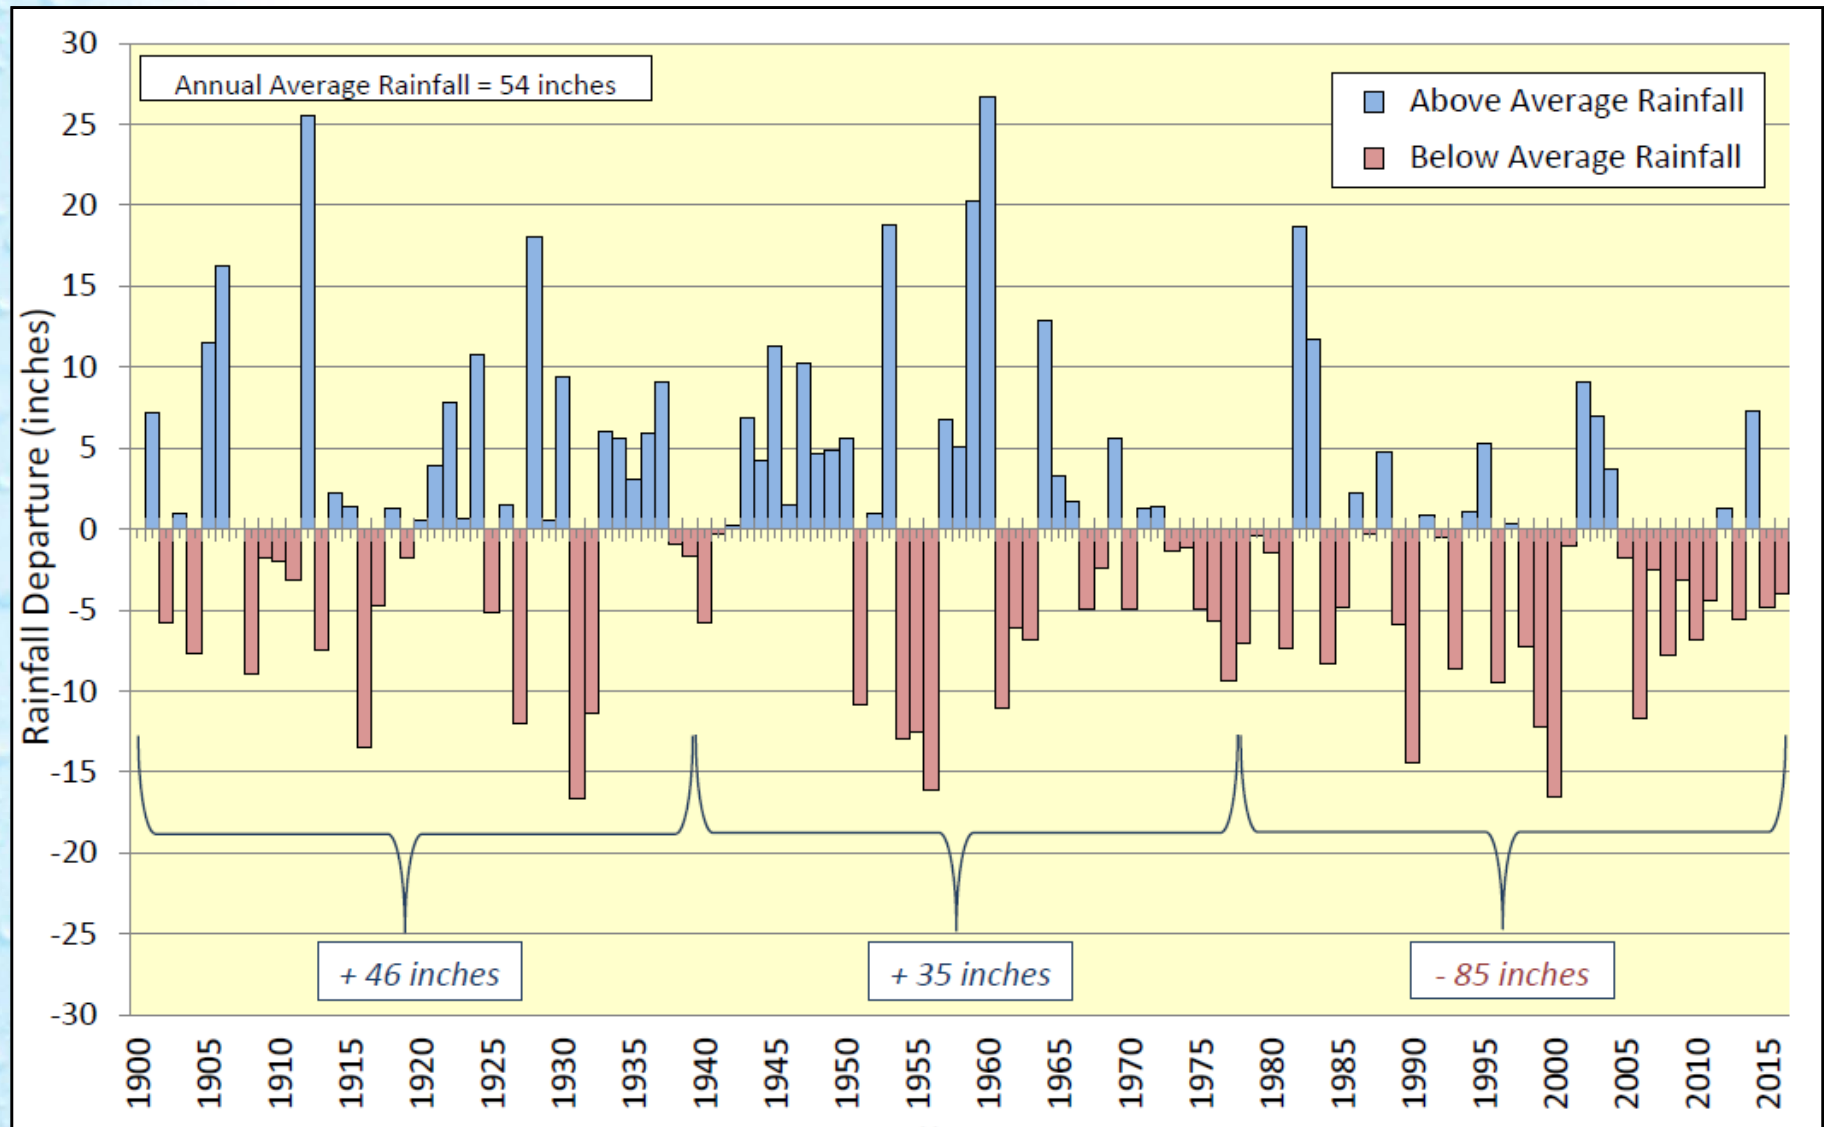
Regional Rainfall...*the past 116 years*

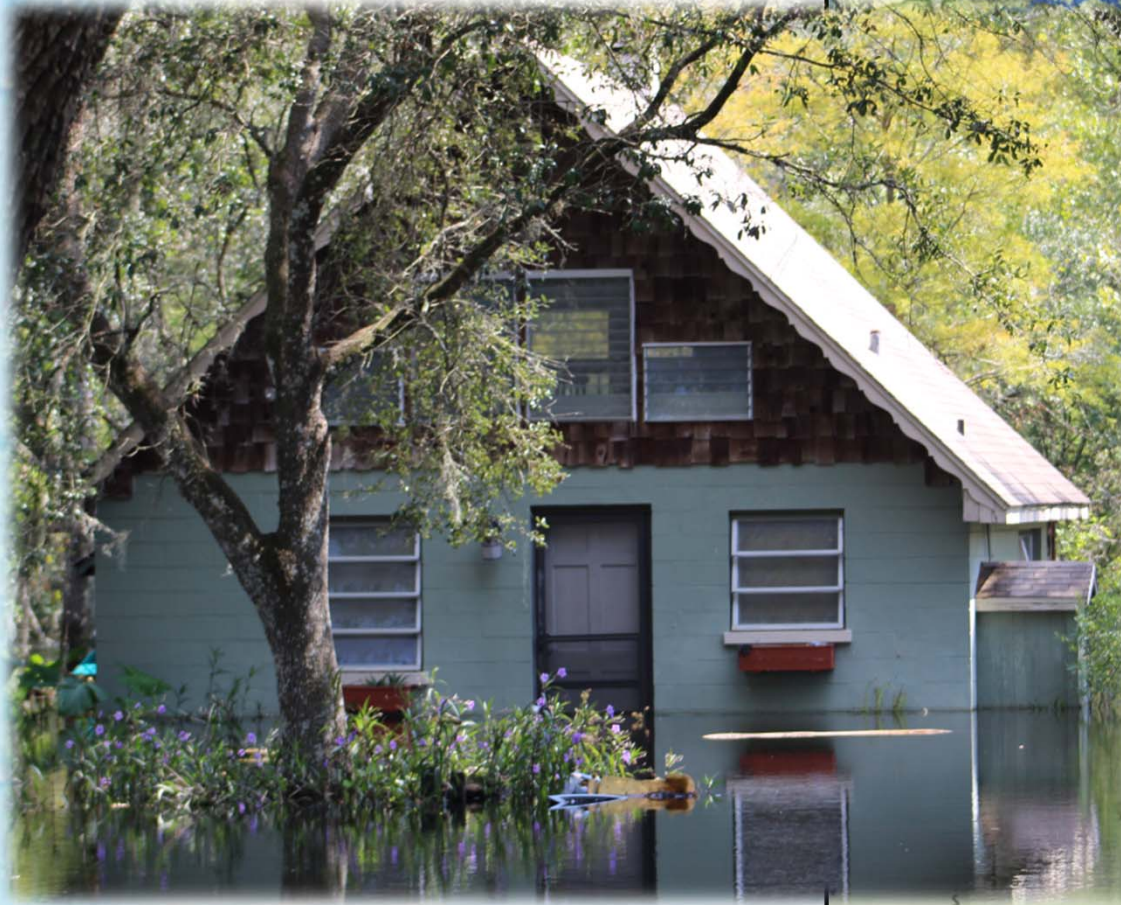
(Lacoochee, Sept 20th)

Hurricane Irma

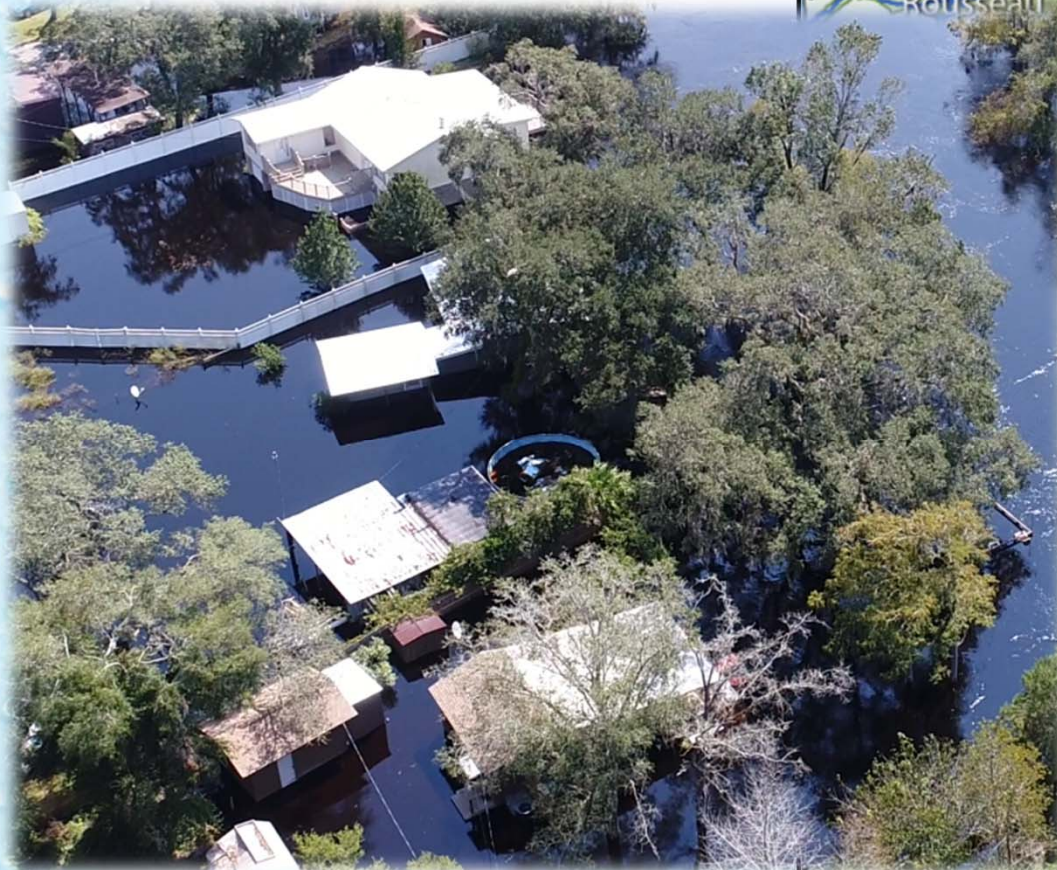
(SR 50, Sept 21st)

Hurricane Irma

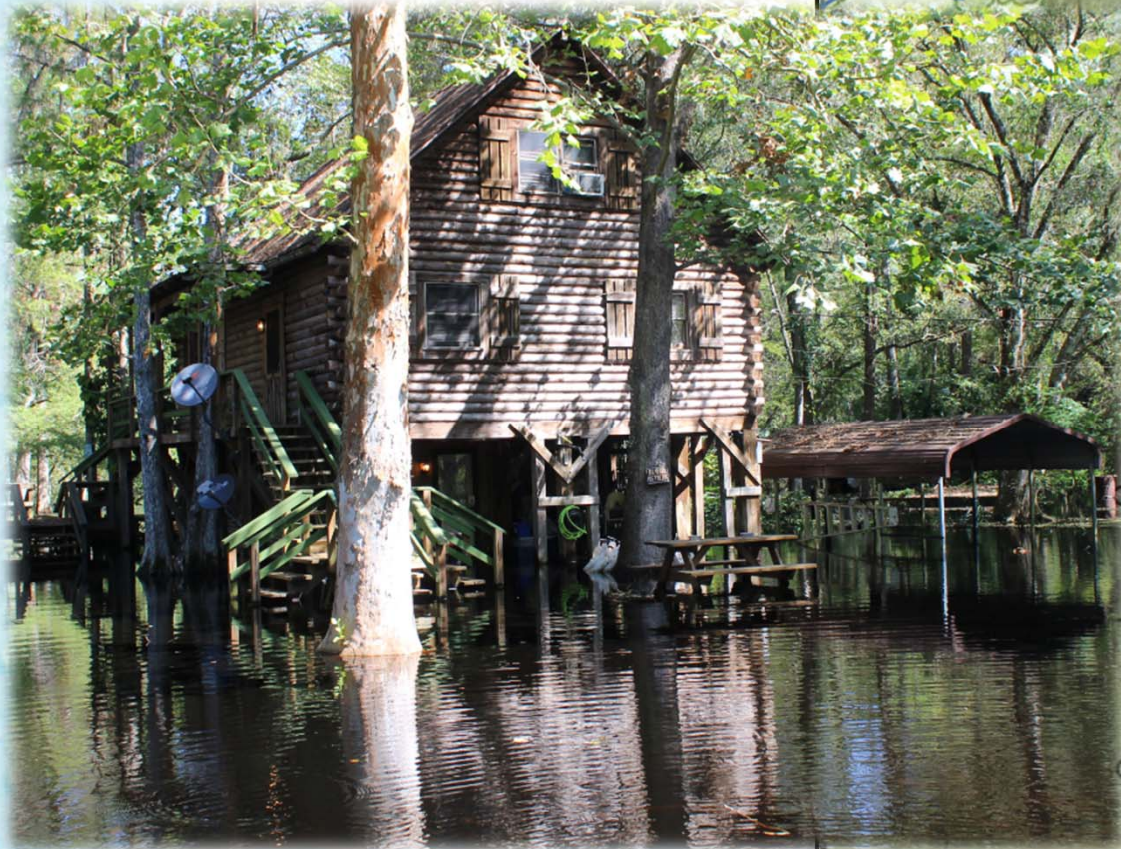
(Nobleton, Sept 23rd)

Hurricane Irma

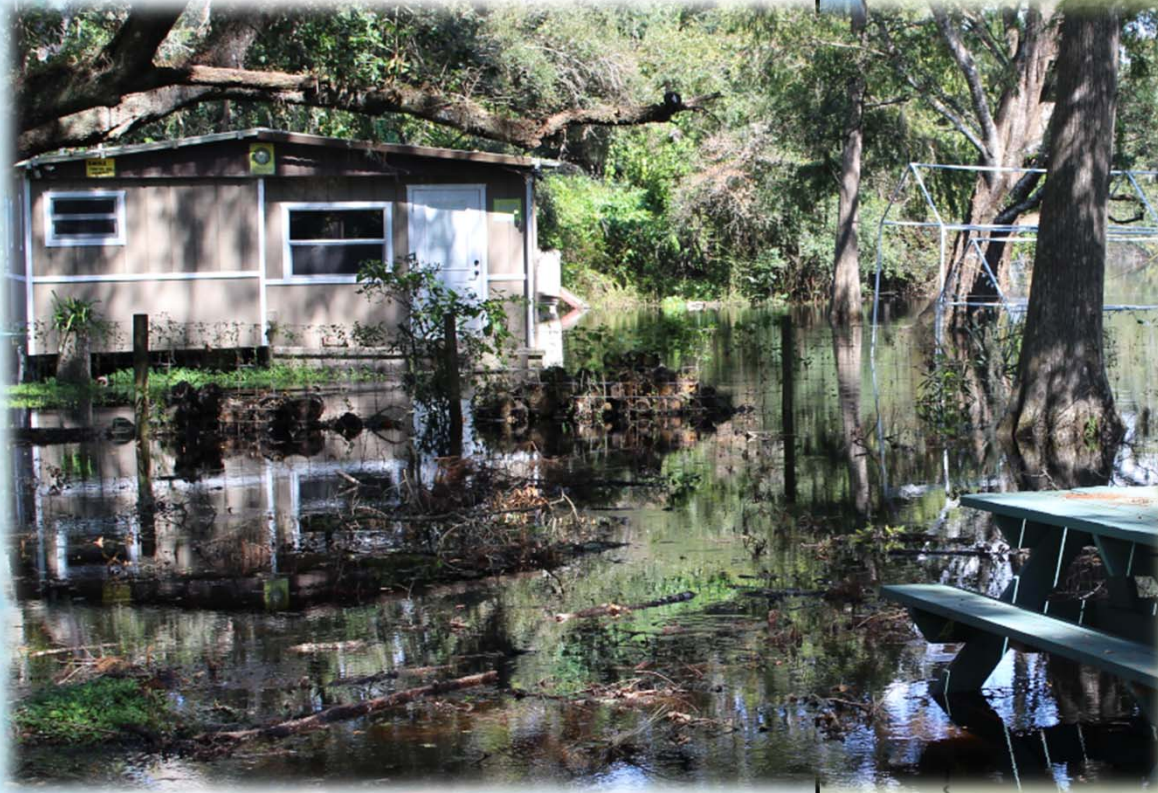
(Trails End, Sept 25th)

Hurricane Irma

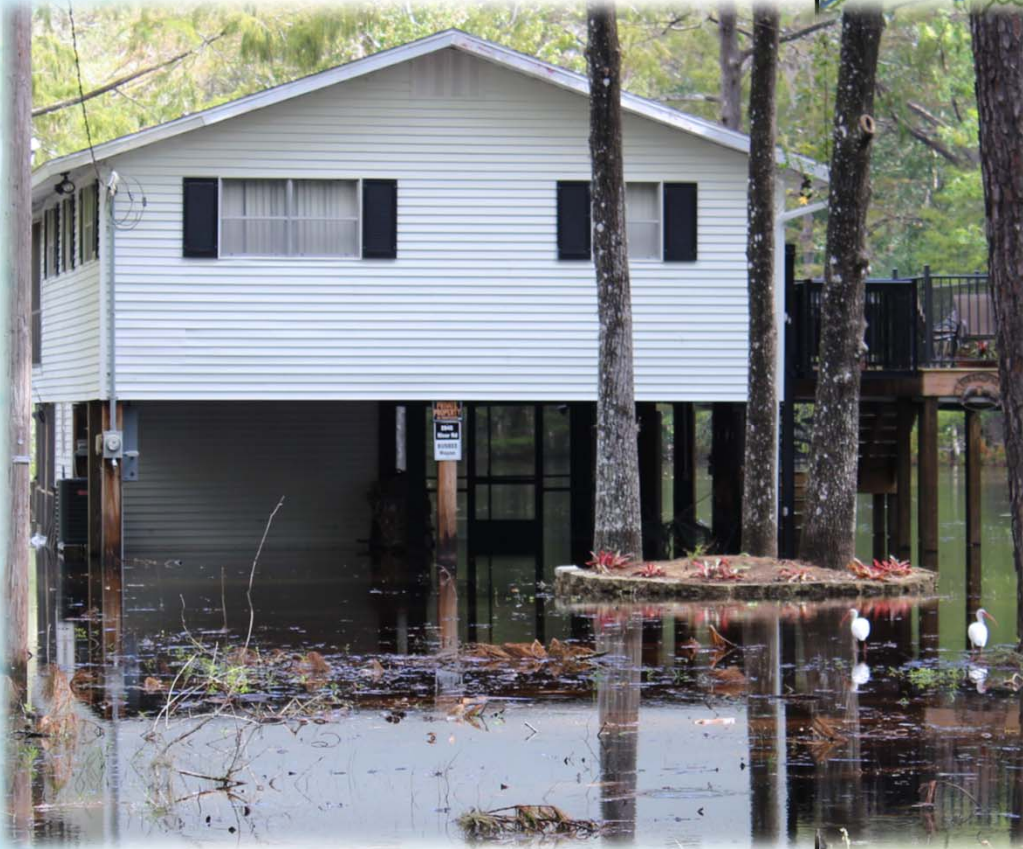
(Arrowhead Estates, Oct 9th)

Hurricane Irma

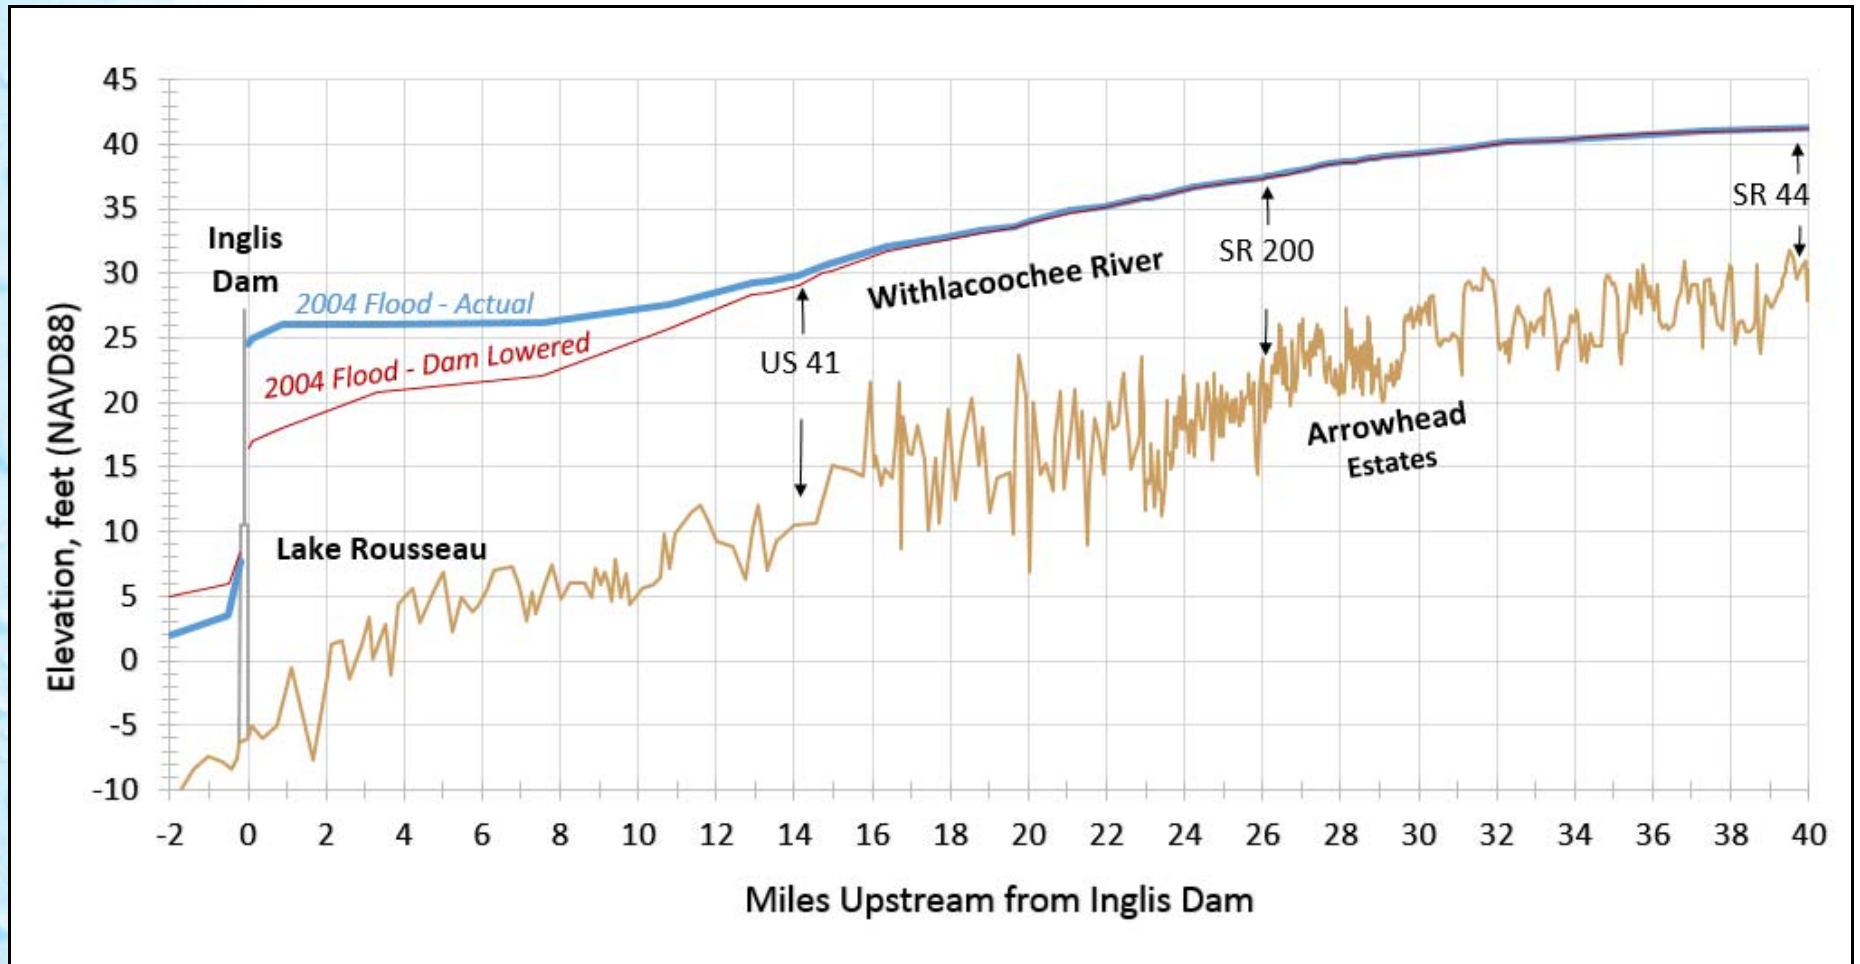
SIMULATING A FULLY LOWERED INGLIS DAM

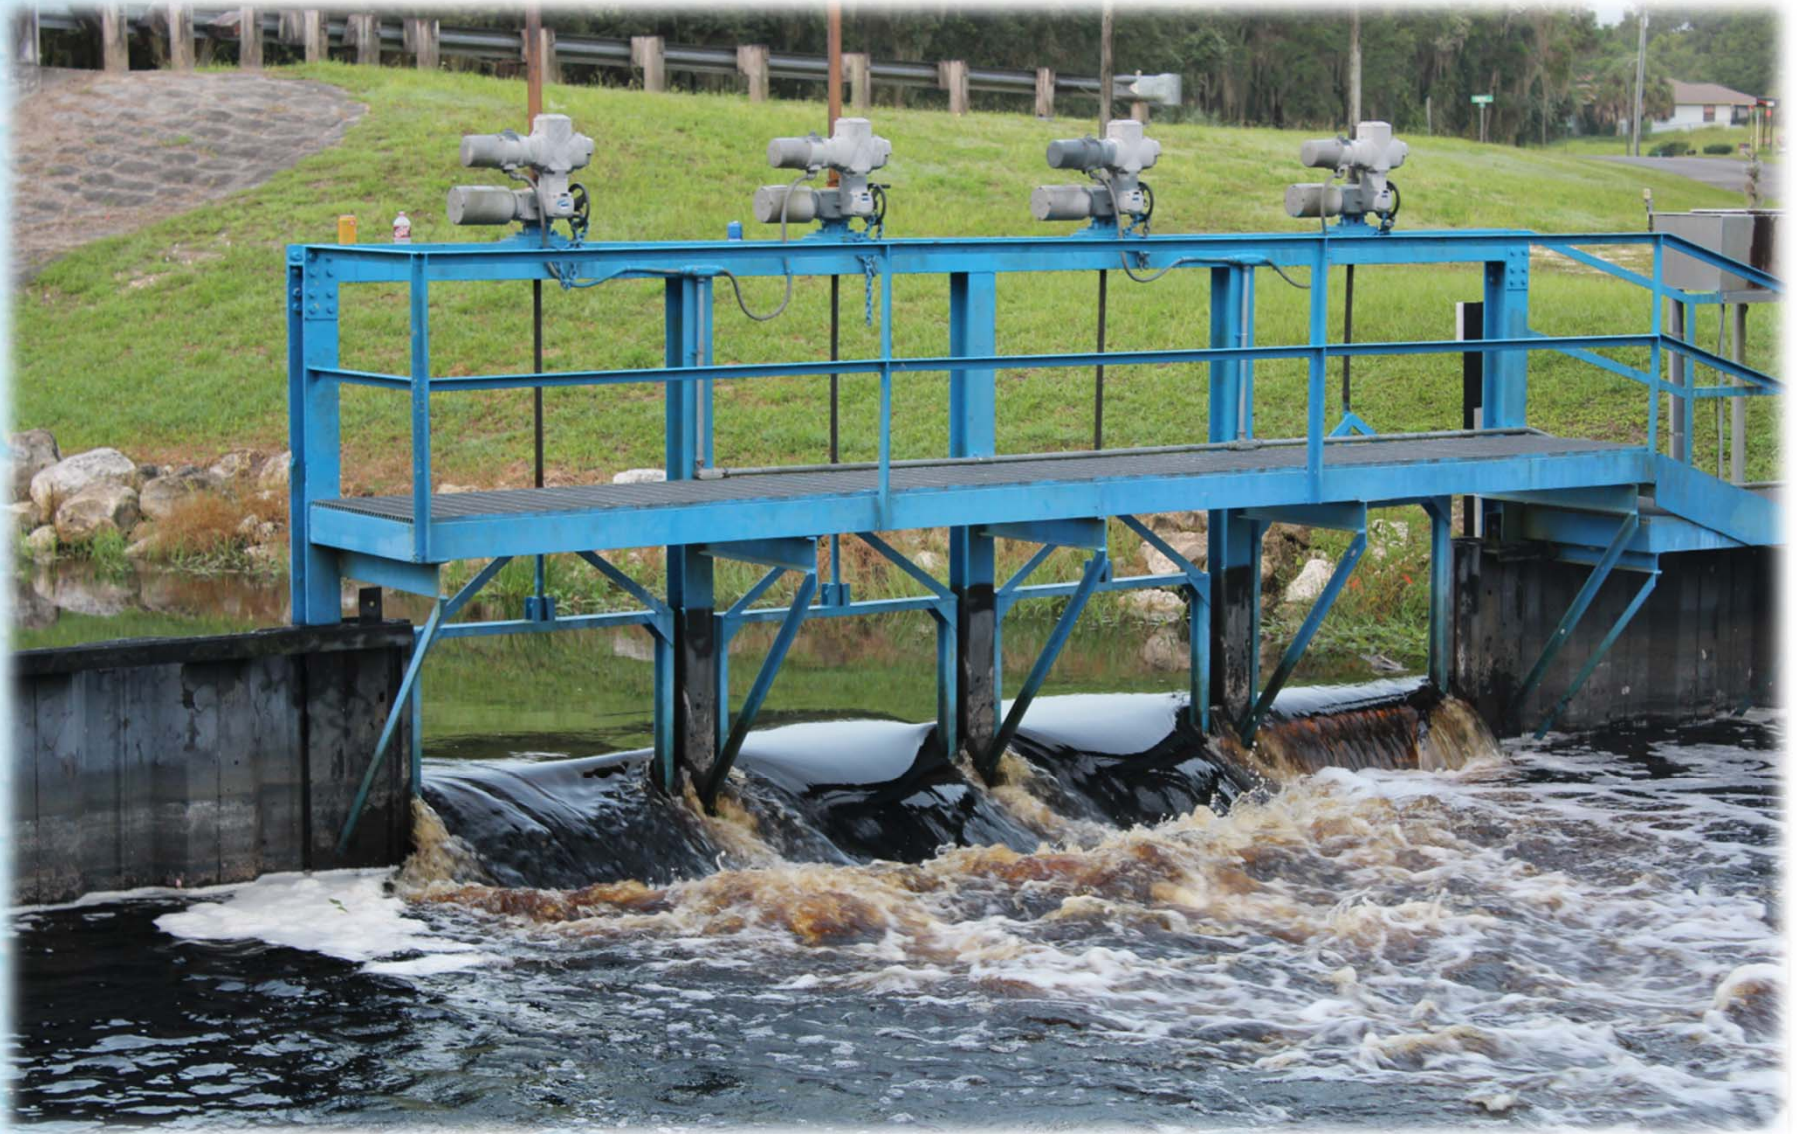
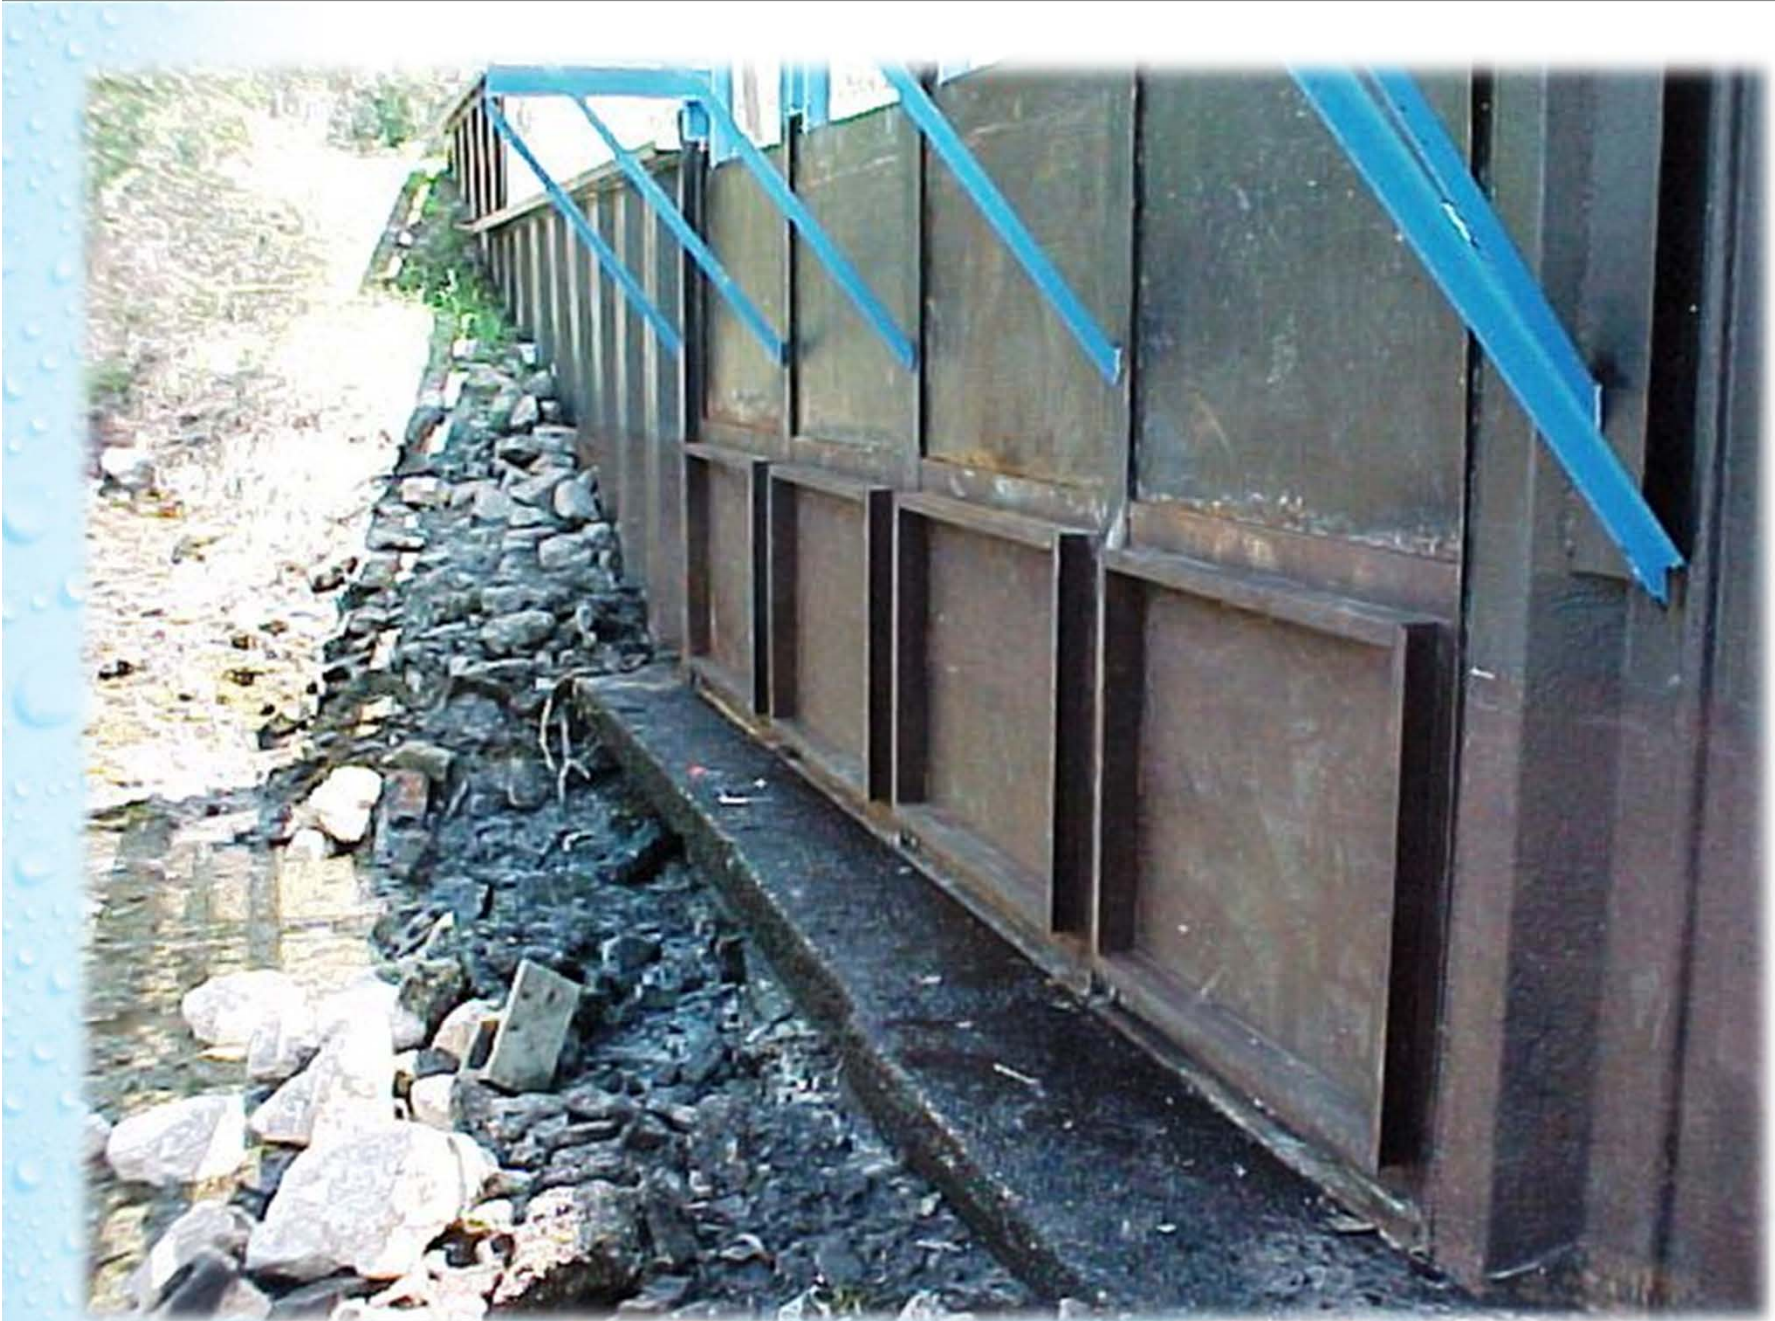
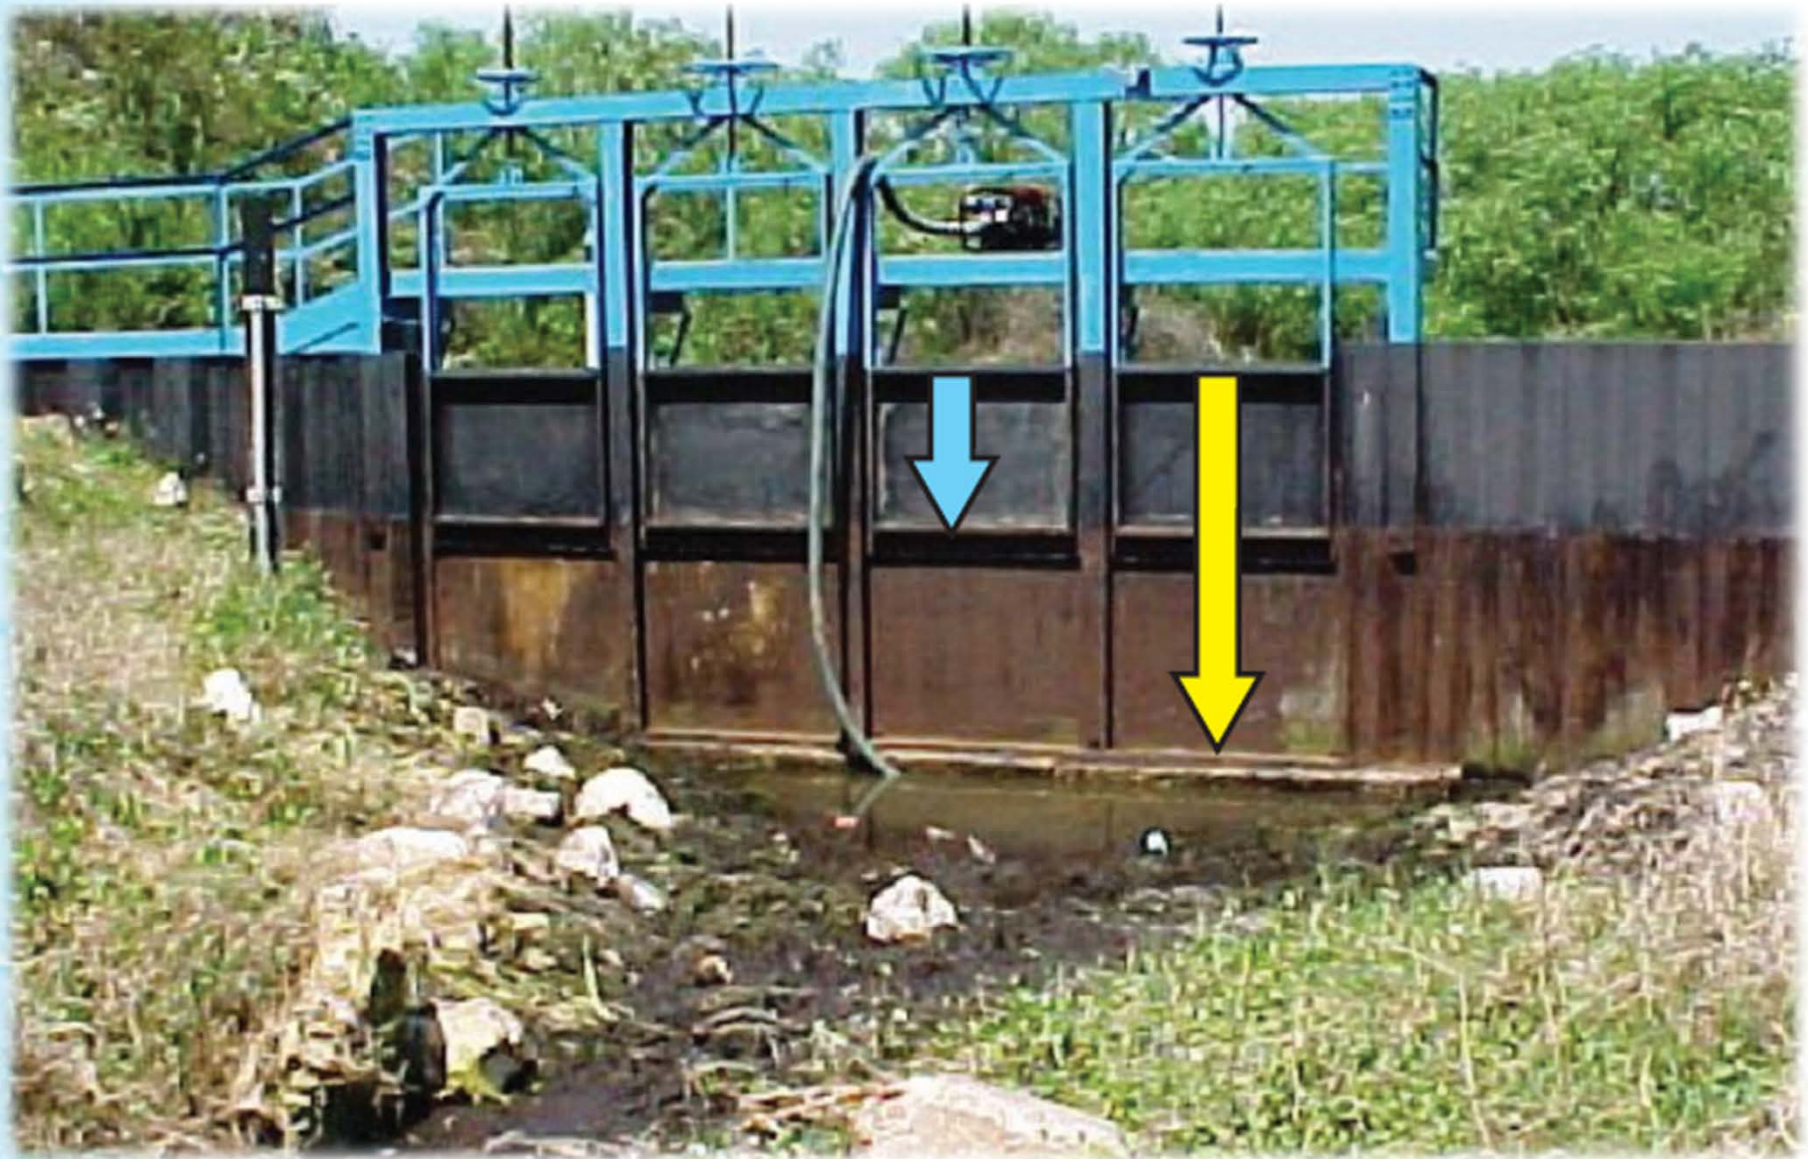
GOLF COURSE STRUCTURE MODIFICATION

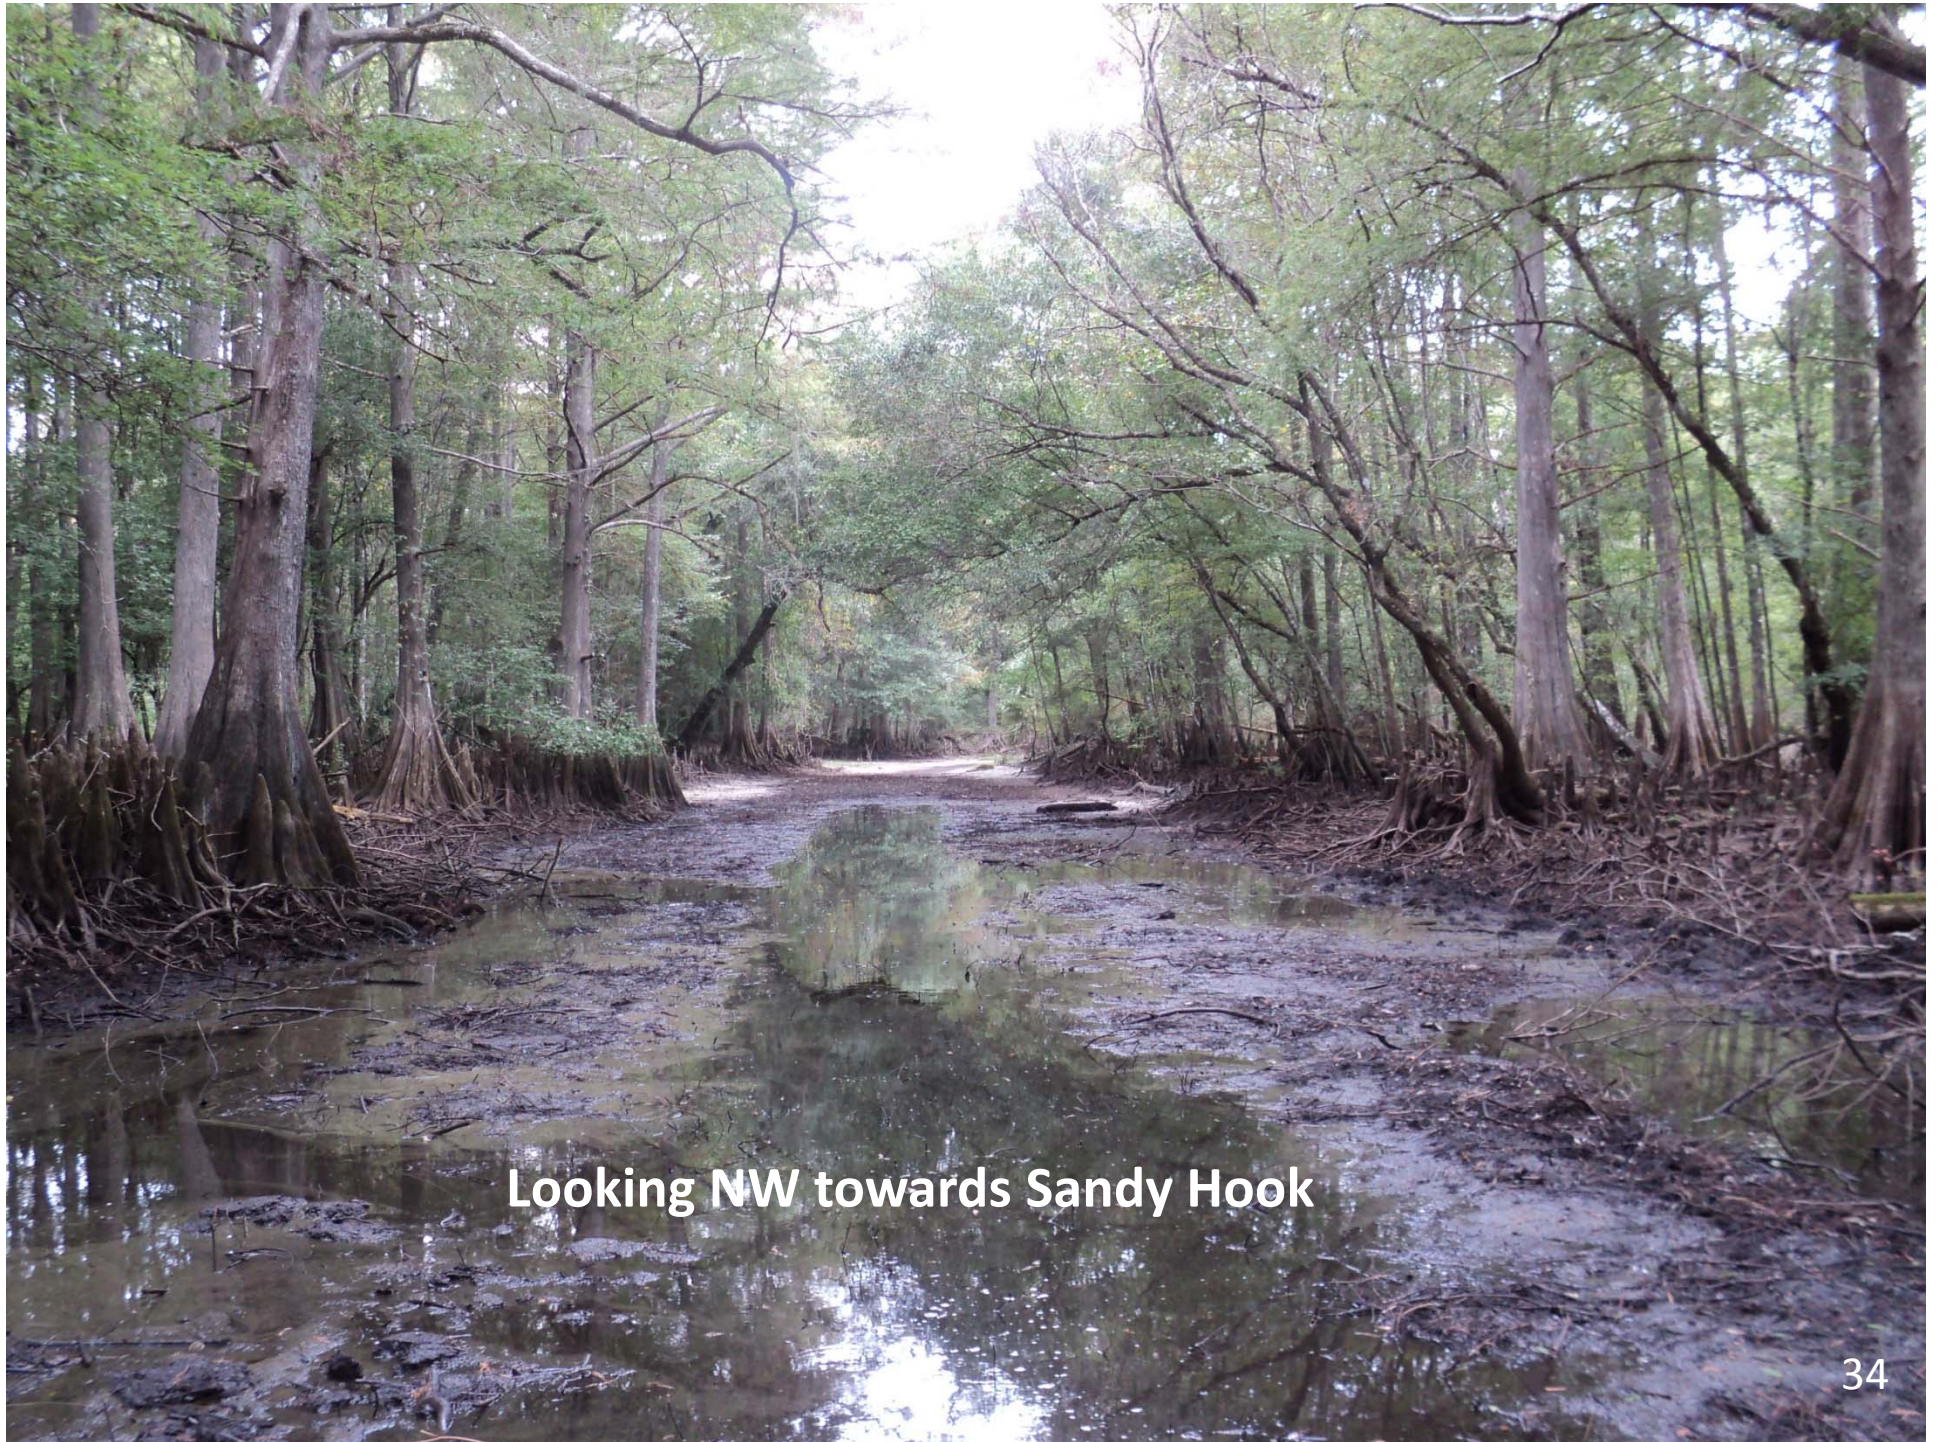
ORANGE STATE CANAL- CONVEYANCE IMPROVEMENT
